# STREETSCAPE RECYCLING

City of Vancouver Pilot

Summary of 2018 Activities

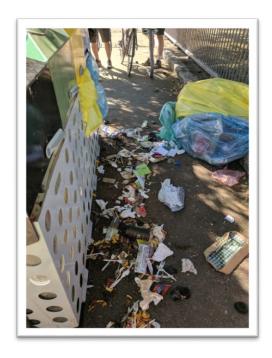
Figure 1 Material cleaned out after getting stuck in the bin

Additionally, there have been operational challenges identified by the collection crews servicing the bins. The most significant issue is when the bins are almost full, and material starts to overflow. In this instance, material falls into the gap between the bin liner and outer metal shell. Enough material falls into this space and makes it difficult for the collection crews to swivel the back door open and empty the contents. Additional time is then needed to dismantle the bin, clean out the inside, and reassemble it.

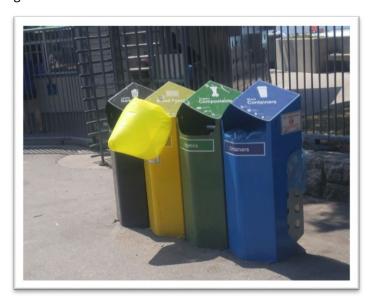
Figure 2 Coloured inner bags blowing out of the bin

Currently, a plastic bag is used inside the bin liner. The plastic bag poses a problem as it doesn't secure to the top of the bin liner, and without an elastic band around it, slides down into the bin liner preventing a likelihood of materials falling in the bag when placed in the bin. Recycle BC would like to remove the need for a single-use plastic bag entirely from the bin design.

Recycle BC recommends the bin liner is redesigned to allow the elimination of single-use bags for collection. In addition, a modified design could allow liquids to drain on site rather than liquids being held, and therefore collected, in the bags, resulting in a lower quality of paper products for marketability.

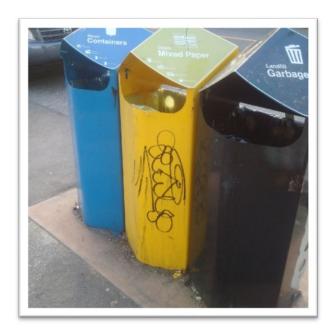
Figure 3 Grime and graffiti on-street bins in pilot area

Because of the empty space on the front and sides of the bin, they are prone to getting tagged with graffiti and having stickers applied. When the bins were originally manufactured, an anti-graffiti coating was applied to them so that graffiti could be easily washed off. The decals were also applied with an anti-graffiti coating for the same purpose. Recycle BC regularly works with the City Vancouver to arrange to have the bins power washed to remove graffiti and any additional grime as part of the regular maintenance of their street furniture.

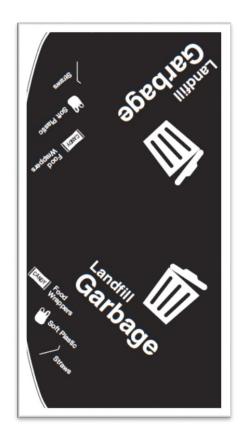
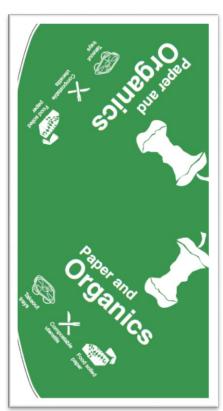
Figure 4 Redesigned Decals Near Second Beach Concession Stand

The City of Vancouver adjusted food packaging for their Second Beach concession stand to offer recyclable or compostable takeout options. A decision was also made to remove the paper recycling bins from this area, to reduce confusion about where to place paper products which for the most part would be food soiled in this area. As a result, signage was adjusted for our two recycling stations in the area, and the City's one recycling station in the area. The City and Recycle BC coordinated the messaging, and new decals were printed and installed in late summer to instruct users to place paper in the organics bin.

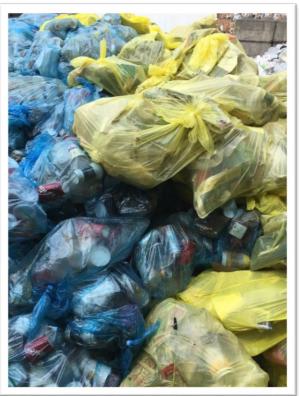
Figure 5 Material Dropped Off at Receiving Facility

Once material arrives at the processing facility, material is weighed and recorded. Bags are emptied off the truck and separated by colour (blue = containers, yellow = paper). Final end life disposition of the material is as follows:

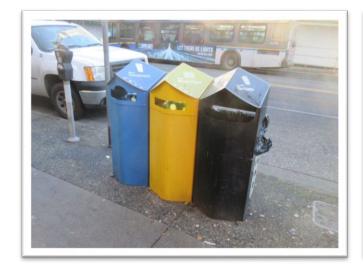
In the short term, a solution was proposed to test out the impact on contamination if the 2016-2017 pilot project bin opening is reduced. New faceplates were affixed onto the bin to narrow the opening, with a horizontal slot for mixed paper and an arced horizontal shape for the mixed containers:

In December 2018, the City manufactured the faceplates from steel, powder coated them in the applicable colour, and installed them for half of the paper and containers bins in the West End area by bolting them to the front.

The impact of this change was assessed during a one week, 7-day audit of each bin by location in January 2019. Results will be reported at a later date.
